Interim (Adaptive) Wet Weather Management Plan

Prepared for
The
General Services Department
City of Chico Parks and Open Space Division

Chico Environmental
Science and Planning

December, 2009

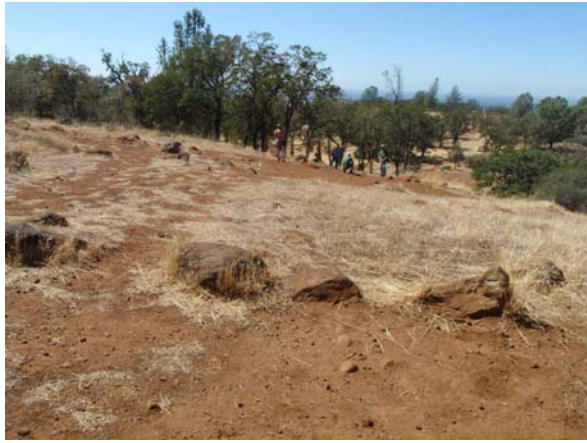
Reference point 1: Looking West from Tee 2.

Vegetation is dry and has been trampled in some areas. Top soil has been eroded from lower portion of original tee area and in path towards target, more rocks visible than last inspection. Trail is .5 feet wider than last inspection. See reference points 2 and 3.

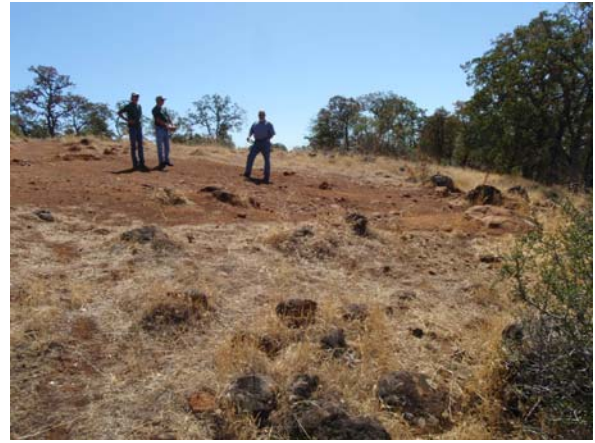
Reference point 2: Looking North from below Tee 2.

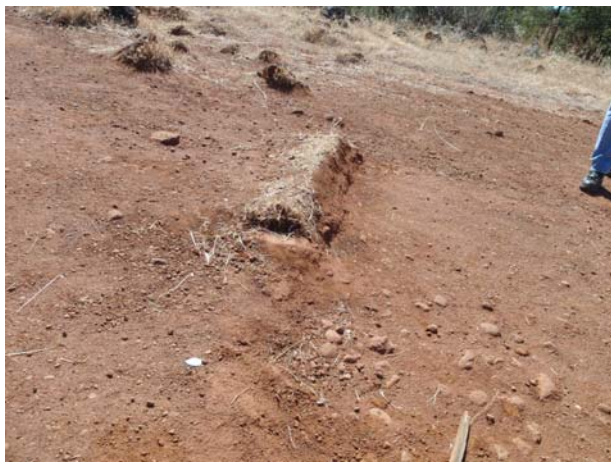
Reference point 3: Previous bench location at Tee 2.

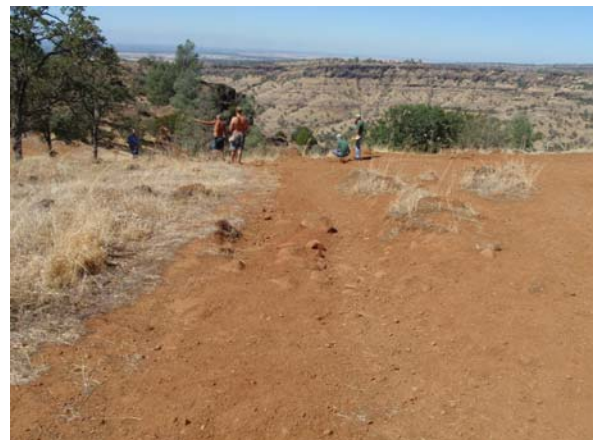
Photo 4: Path is eroding. More exposed rocks and less soil.

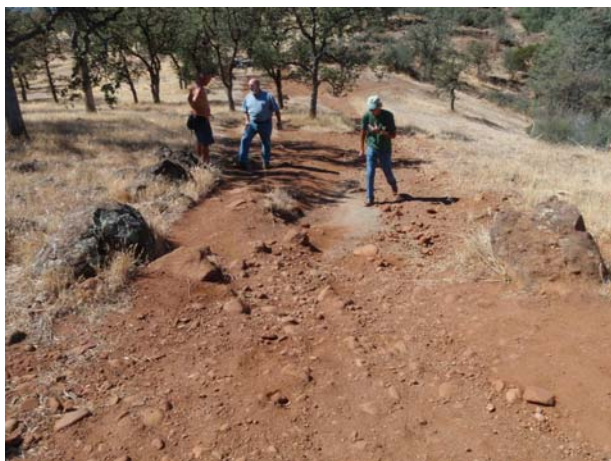
Photo 5: Additional erosion and mtn bike tracks.

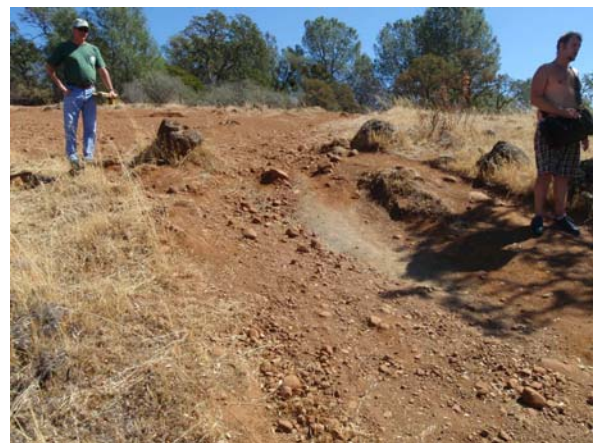
Photo 6: Deep rut with horse prints.
